# APPENDIX A

### **Appendix A: Natural Resources**

## PEASE PARK NATURAL AREAS MANAGEMENT GUIDELINES

## Natural Areas Management Guidelines Pease Park Master Plan

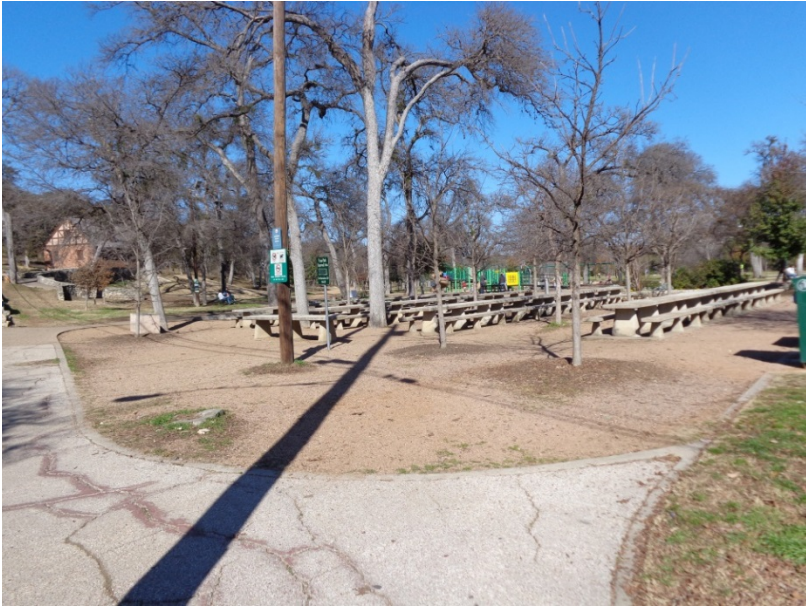
**Photopoint: 1**      **Direction: N**

Main picnic area at Kingsbury Commons with concrete Works Projects Administration era benches. Large cedar elms have severe mistletoe infestations and will require extensive pruning. Young trees, principally burr oak and cedar elm have been interplanted in the older cedar elm

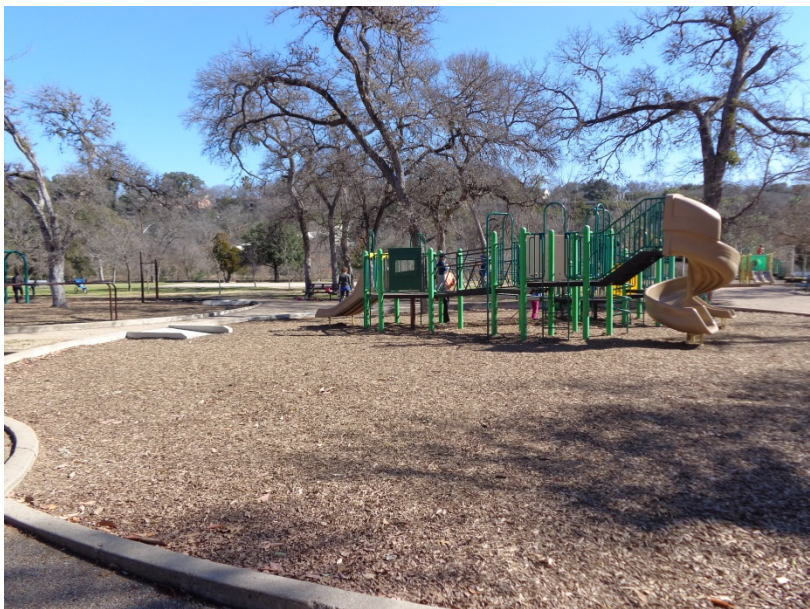
**Photopoint: 4**      **Direction: E**  
Playground with large, mistletoe infested, cedar elm.

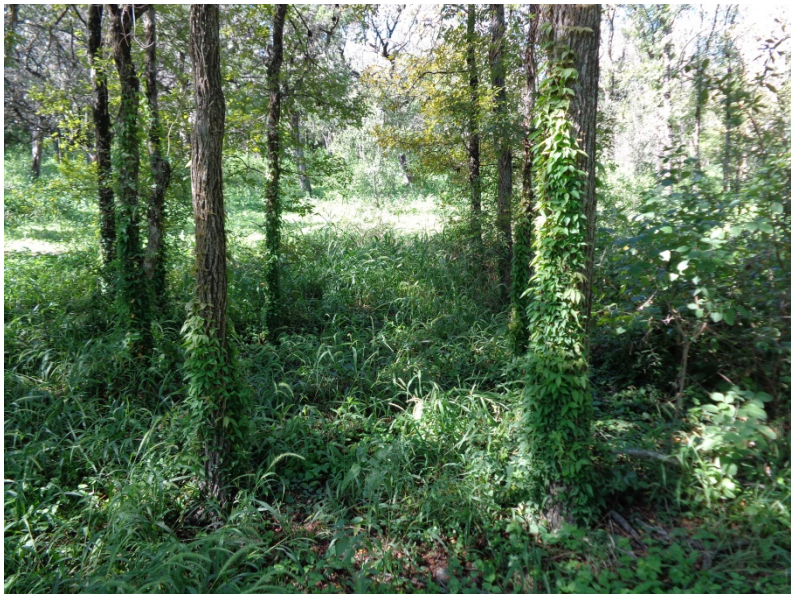
**Photopoint: 6**      **Direction: N**  
Small infestation of the non-native invasive catclaw vine.

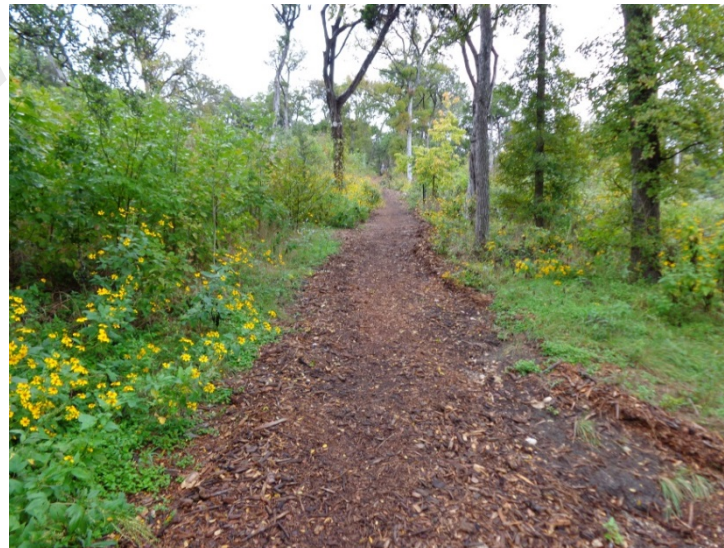
**Photopoint: 12**      **Direction: NW**

Representative picture of mulched trails found in the Hillside and North Ramble areas. These trails do not contain waterbars or other ways for water to exit the trail, which is already leading to minor erosion problems that will likely become worse unless trails are improved.

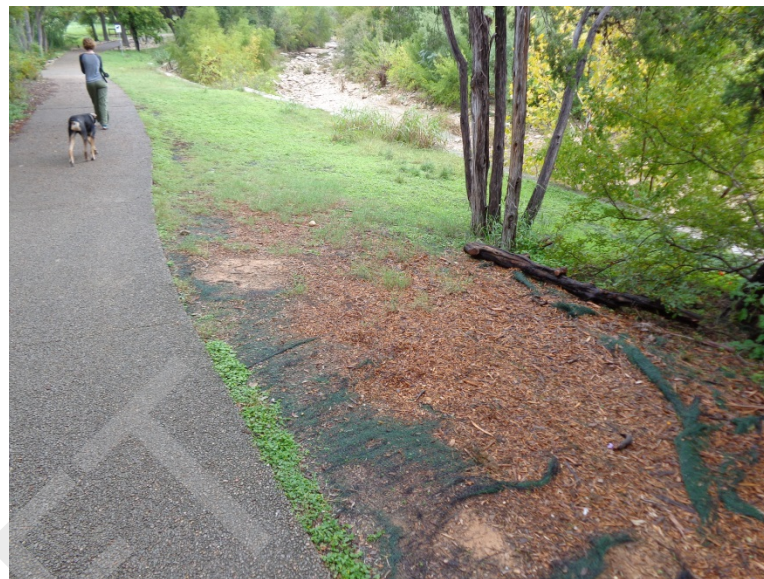
**Photopoint: 14**      **Direction: NW**

Section of trail with large amount of exposed erosion control blankets that are beginning to degrade and fold.

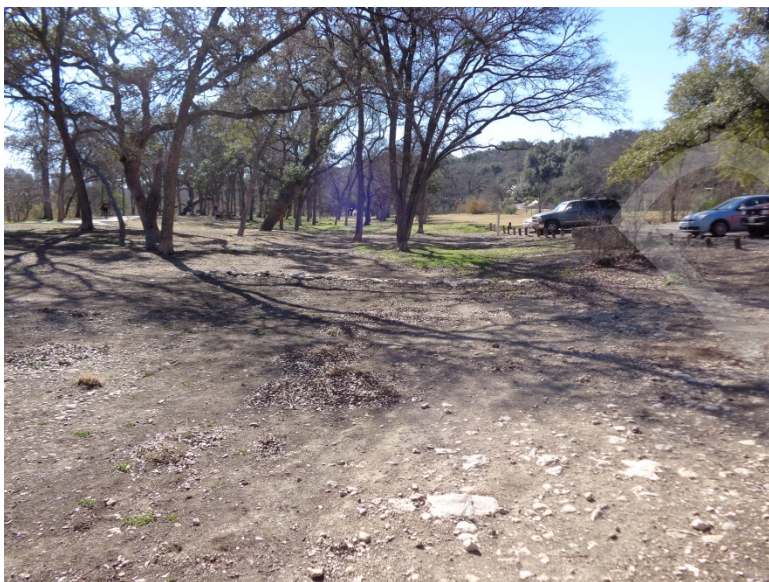
**Photopoint: 23**      **Direction: S**

Parking lot and erosion at high use area of Custer's meadow.

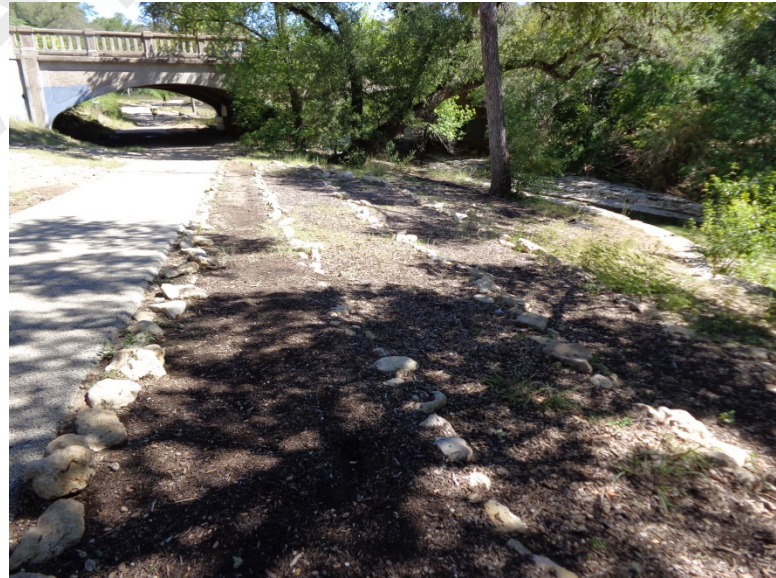
**Photopoint: 26**      **Direction: NNE**  
Rock terraces are slowing soil erosion, but this area has yet to revegetate.

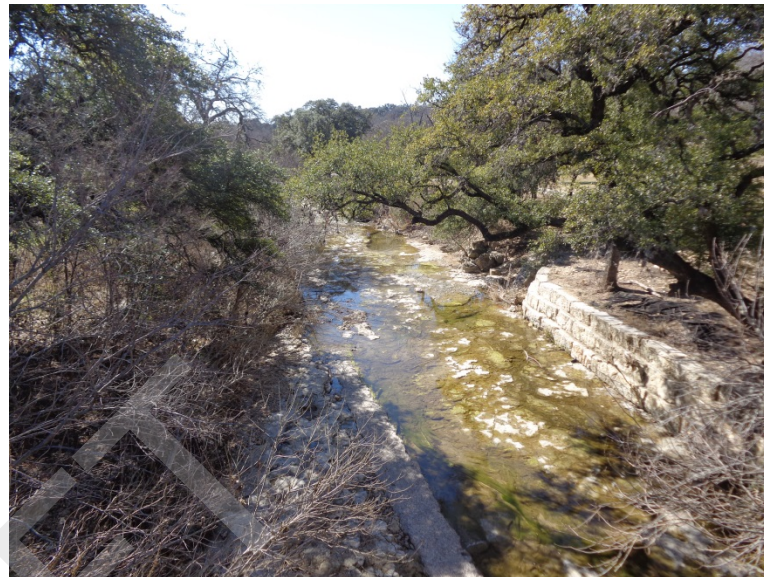
View of creek from the 24<sup>th</sup> Street bridge. Many stately live oaks are found in this section of the creek, although erosion is exposing the roots of the live oaks in the right side of this picture.

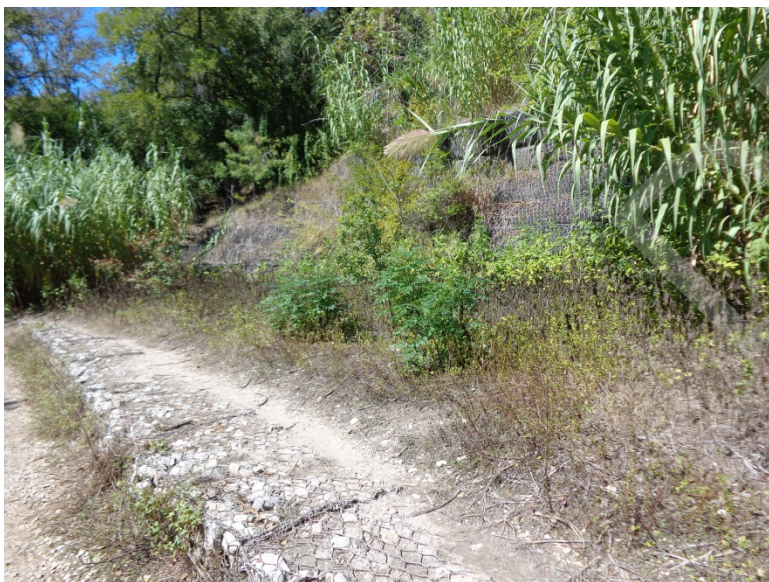
**Photopoint: 46**      **Direction: W**

Gabian wall where a seep contributed to slope failure in the past. The slope is now dominated by Giant Cane.

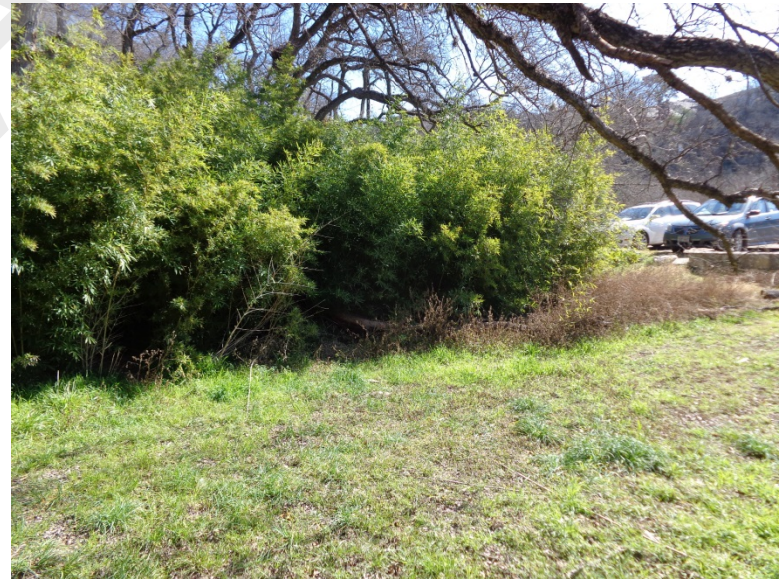
**Photopoint: 49 Direction: E**  
Bamboo infestation at the northeast edge of Gaston Green.

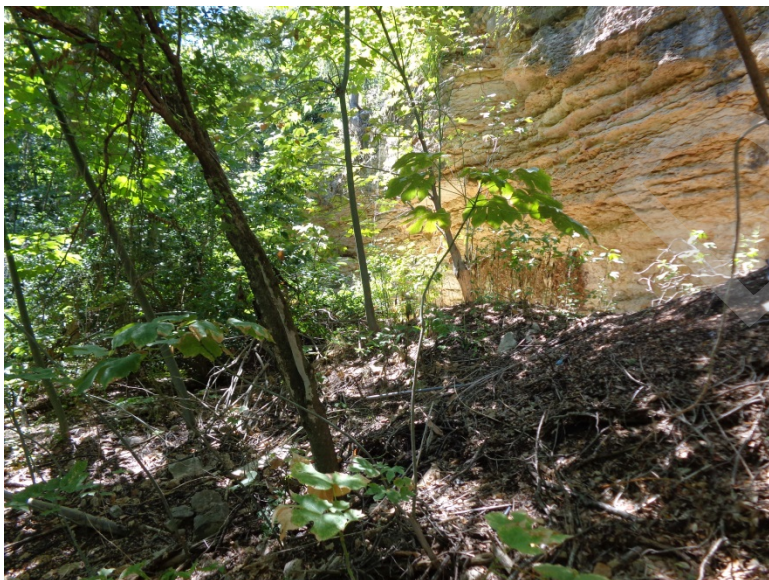
**Photopoint: 60**      **Direction: S**

Cliff face with Chinese parasol tree infestation at its base. Homeless encampments are frequently found under cliff overhangs in the project area.
